Coastal Protection and Restoration Authority of Louisiana

2007/2008 Annual Inspection Report

EAST MUD LAKE MARSH MANAGEMENT PROJECT (CS-20)

State Project Number CS-20
Priority Project List 2

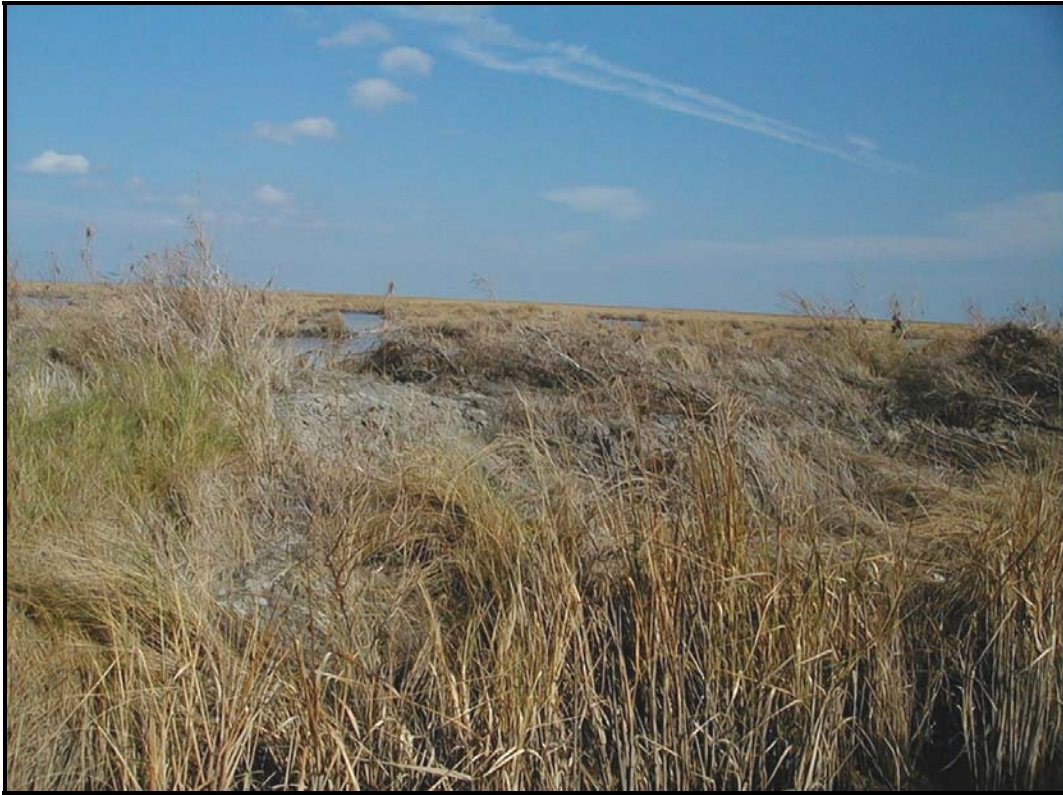
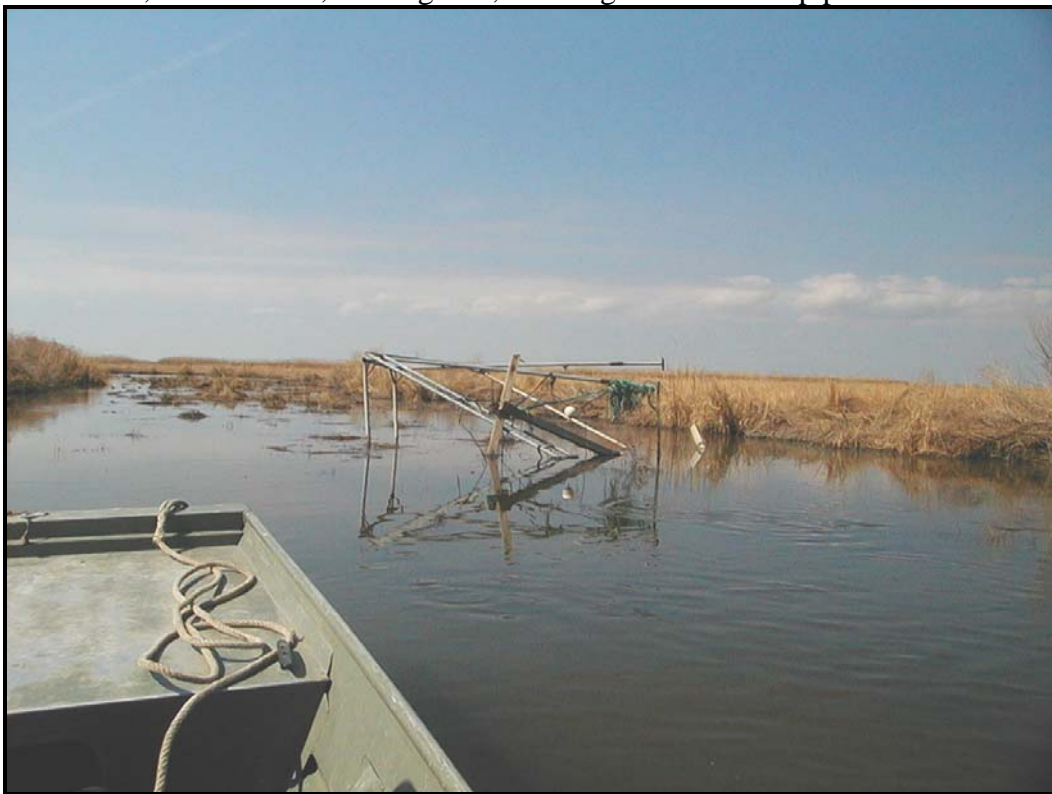
The inspection of the earthen levee consisted of a visual inspection of the entire length of levee along the Step Canal. In addition to the erosion noted above, the storm surge has eroded portions of the levee in various locations. In addition the storm surge has placed large amounts of marsh and other debris into the east-west sections of the Step Canal. In these areas of the canal, the water depth was very shallow. The north-south sections appear to be relatively free of any obstructions. LDNR and NRCS agree that maintenance is required to repair the levees and remove trash from the canal. (Photos: Appendix B, Photos 21 & 22).

Photo 21, North Levee, looking east, showing washout of top portion of levee.

Photo 22, Step Canal, view looking west, showing marsh/siltation and other debris in the canal.

- Levee/Step canal – repair levees and remove trash/debris and silt from canal.
